Photo of the Month for July: The railway bridge on Kaiser-Wilhelm-Straße

Abbreviation for factory workers and schoolchildren // Photo from 1979 shows a bridge from the 1930s

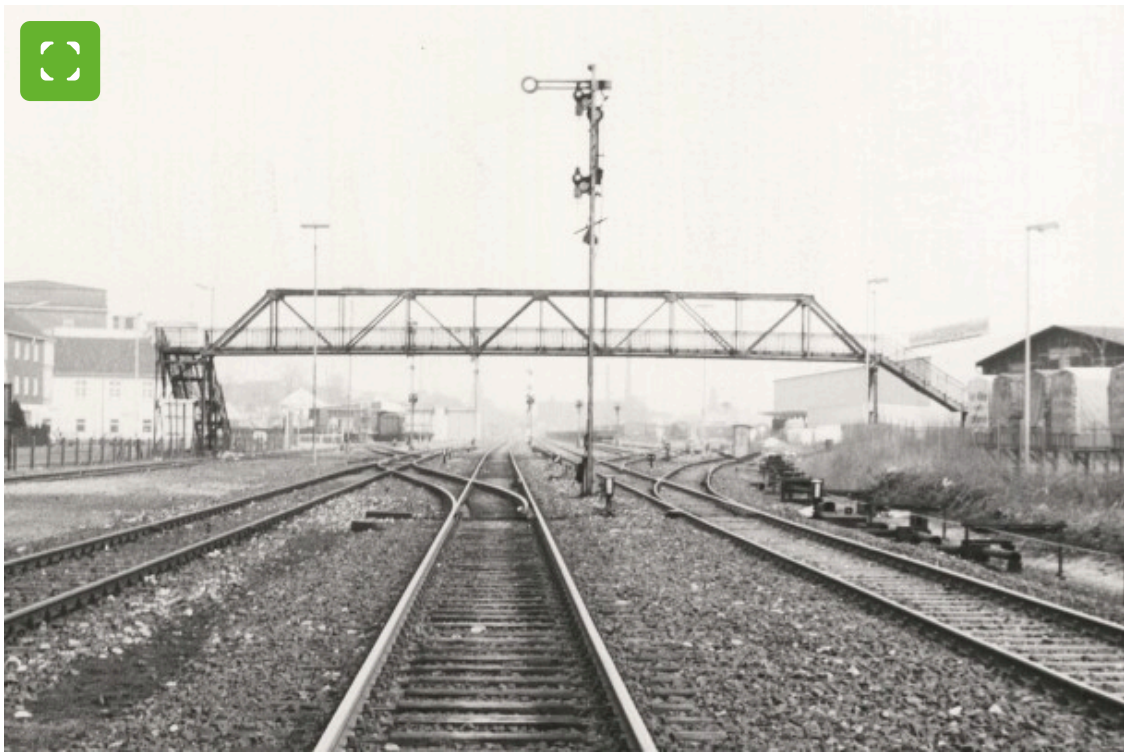
Photo: Bocholt City Archives, Image Collection No. 6159, Text: Wolfgang Tembrink

The railway footbridge was approximately 40 metres long in total. Its steps on Kaiser-Wilhelm-Straße, with an intermediate platform, ran at right angles to the actual crossing. Behind the locomotive shed, which was demolished in 1988, one descended via a flight of steps running parallel to the main walkway and then reached Mühlenweg. This first footbridge was already dilapidated by 1933 and was replaced by the aforementioned new structure, built a few metres further south, which was dismantled in the mid-1980s following a prolonged closure. The photograph shows the engineering structure from the south in November 1979. Many pedestrians will still remember the melodious sound on the bridge. It was caused by the wooden planks, which were laid end-to-end on the iron structure of the footbridge and produced an echo when walked upon at a brisk pace.

The railway bridge on Kaiser-Wilhelm-Straße
